# ROOFS

## Introduction

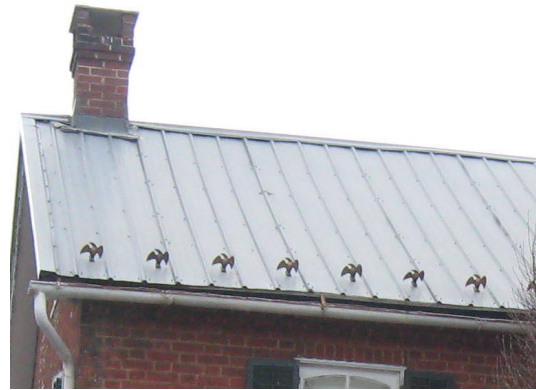
Metal roofing began to be used in the nineteenth century. After about 1850, when manufacturing facilities for these products were established in the United States, sheet metals became more popular. To cover roofs of low or moderate pitch, individual sheets are joined by upright (standing) or flat seams. This is probably the most common roofing material in Mercersburg.

Deterioration: Metal roofing can last a long time if properly maintained. Early metal roofs were painted regularly. However, metal will deteriorate and will eventually rust. Metal roofing can also deteriorate from chemical action caused by pollution and acid rain, which cause pitting and streaking. Because metal expands and contracts with changes in temperature, metal roofs are subject to thermal movement, buckling, and warping. These problems can lead to cracks in joints and open seams. Metal roofs are also subject to corrosion that occurs when incompatible materials, such as copper sheets and iron nails, are in direct contact. If metal roofing is severely rusted, if it contains numerous holes and splits, if several sheets have buckled or warped, if edges and joints are disfigured, or if there are large areas of thin or worn material, consider replacing the material in kind. If only a few spots have rusted or if a few holes exist, proceed with repair rather than replacement. If a single sheet has slipped, repair it.

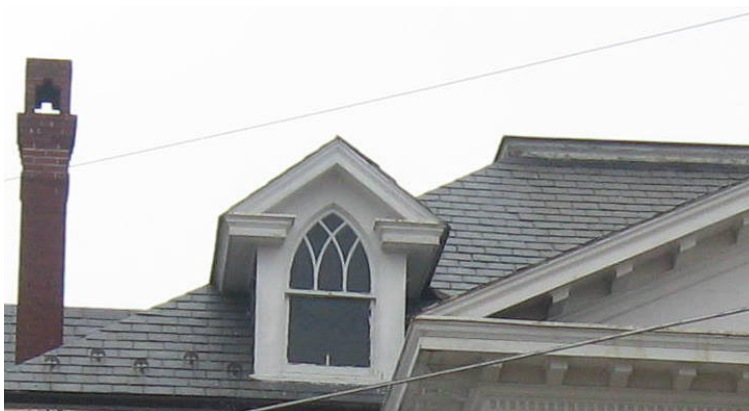
Slate began to be used during the Colonial period, but its initial use was limited because of cost. In the mid-nineteenth century, canals and railroads made slate more accessible and economical, and it became more widely used. The color and texture of slate varies according to its place of origin. Grey, blue, and green shades are available. In Mercersburg, grey and blue-gray slates are common. The remaining slate roofs in Mercersburg are a significant historic resource; their preservation should be a priority.

Deterioration: The most typical problem with slate is with the nails used to install it. Iron nails usually fail before the slate does. If this happens, reattach the historic slates with copper nails and copper flashing. Another problem with slate is delamination. As slate weathers, its surface is slowly chipped away. The slate scales and thin layers flake off. The slate eventually becomes soft and spongy and the inner layers begin to fall apart. In this condition, slate will hold moisture and can cause adjacent wood to deteriorate. Slate in this condition should be replaced. Missing slates or slates with visible holes, cracks, or breaks should also be replaced. Slates that have slipped should be reattached. A simple method to determine the condition of slate is to press firmly on the slate with your hand. Sound slates will be unaffected. Deteriorated slates will feel brittle and crack.

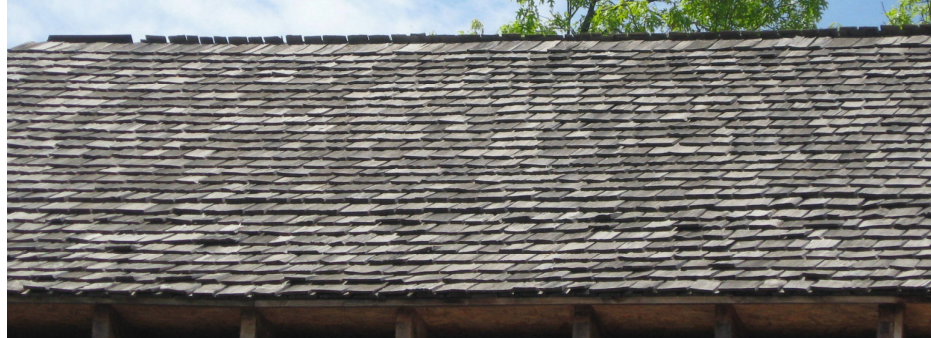
Wood shingles of white pine, oak, elm, cypress, redwood, and red cedar were used for roofing throughout American architectural

history. Because they were a fire hazard, wood shingles were typically replaced as other more fire resistant materials became available.

Deterioration: Wood shingles are subject to all the typical type of exterior wood deterioration. (See *Exterior Wood and Siding* chapter) If wood shingles appear thin, eroded, cracked, cupped, split, spongy, or warped, the shingles are probably no longer providing sufficient weather protection. If only a few shingles are missing or damaged, replace them individually. Splits or holes in wood shingles can be treated with a piece of aluminum or galvanized steel under the shingle and roofing cement in the hole or crack. Moss and fungi on wood shingles hold moisture that can speed deterioration. Attempt to dry the roof by trimming trees that block the sun, and consider fungicide treatments. If a significant amount of water damage is visible in the attic, consider shingle replacement.

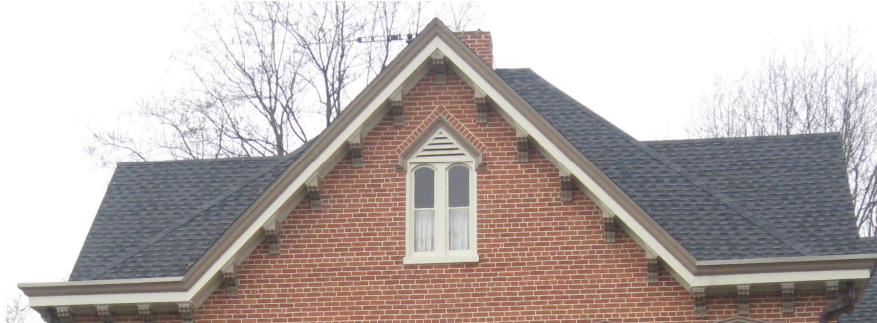
Asphalt shingles were introduced to the building market around 1890 and gained wide popularity by about 1910. Asphalt shingles are made of asphalt-saturated felt or fiberglass, embedded

with mineral granules to reflect the heat and ultraviolet rays of the sun. They were considered a good roofing material because of their relative inexpensive cost and their fireproof quality. If your building was constructed before 1890 and it currently has asphalt shingles, the roof was probably originally covered with slate, wood, or metal.

Deterioration: Asphalt shingles can deteriorate due to inappropriate installation. Wind can lift and dislodge them. Over time, shingles may curl and lose their mineral covering. If more than 20% of asphalt shingles have curled or warped, if the mineral granule surface has been abraded, if they are cracked or dried out, if the overall surface is lumpy, if moss covering is pervasive, or if the surface has been numerous and repeatedly patched, consider replacement. Remember that trees may stain light colored shingles.

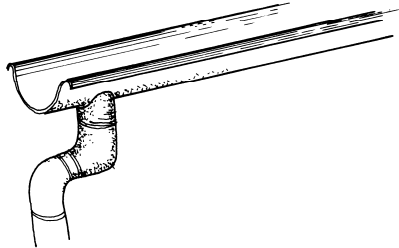
Half Round Profile

Gutters with a half-round profile are more appropriate for historic structures than the K-style profile. Plain round or rectangular downspouts are more appropriate for historic buildings than corrugated ones.

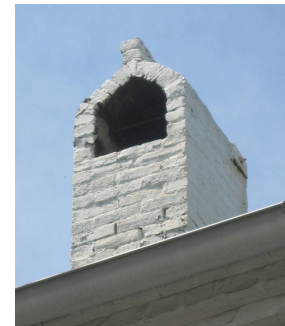
**Chimneys:** One of the main elements in the visual profile of a house is its chimney, and many chimneys were originally built to match the architectural style of the house. For these reasons, the character of a chimney should be retained when improvements are being made. Because of their exposed position, chimneys are particularly susceptible to the effects of wind, rain, and frost. Brick and stone chimneys are subject to the same problems as brick and stone walls. (See the *Masonry* chapter of this manual for additional information.) Deteriorating flashing can also be a problem. Even if chimneys are no longer in use, they should not be removed or replaced.

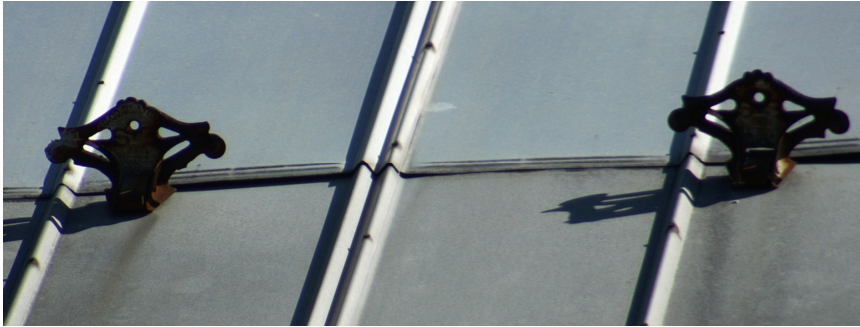
Snow Guards: Snow guards, also called snowbirds, are often found on Mercersburg's roofs. They were traditionally installed to avoid dangerous ice slides and to protect gutters, eaves, and cornices from snow and ice damage. Many of these elements were decoratively designed. They are often found near the eaves at the lower edge of slate and metal roofs in staggered rows, or on steeper roofs in greater quantities. The number of snow guards used depended on the slope of the roof. Iron or copper were typically used. Whenever possible,

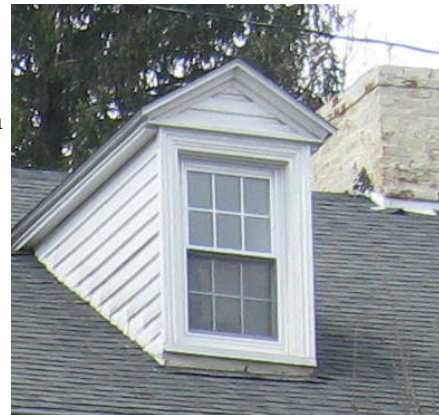
Dormers: Existing dormers should be carefully maintained and repaired as necessary. Avoid adding new dormers to prominent slopes of the roof. If they are added on other slopes, they should be in proportion to the building. New dormers should have roof forms that match those of existing dormers, or if historic dormers are not present, the dormer roof should match the house roof or should be compatible with it. (See the *Windows and Doors* chapter of this manual for more information on windows.)
